Fractography of Ceramics and Glasses

Special
Publication
960-16e2

NIST Recommended Practice Guide

Materials Measurement Laboratory

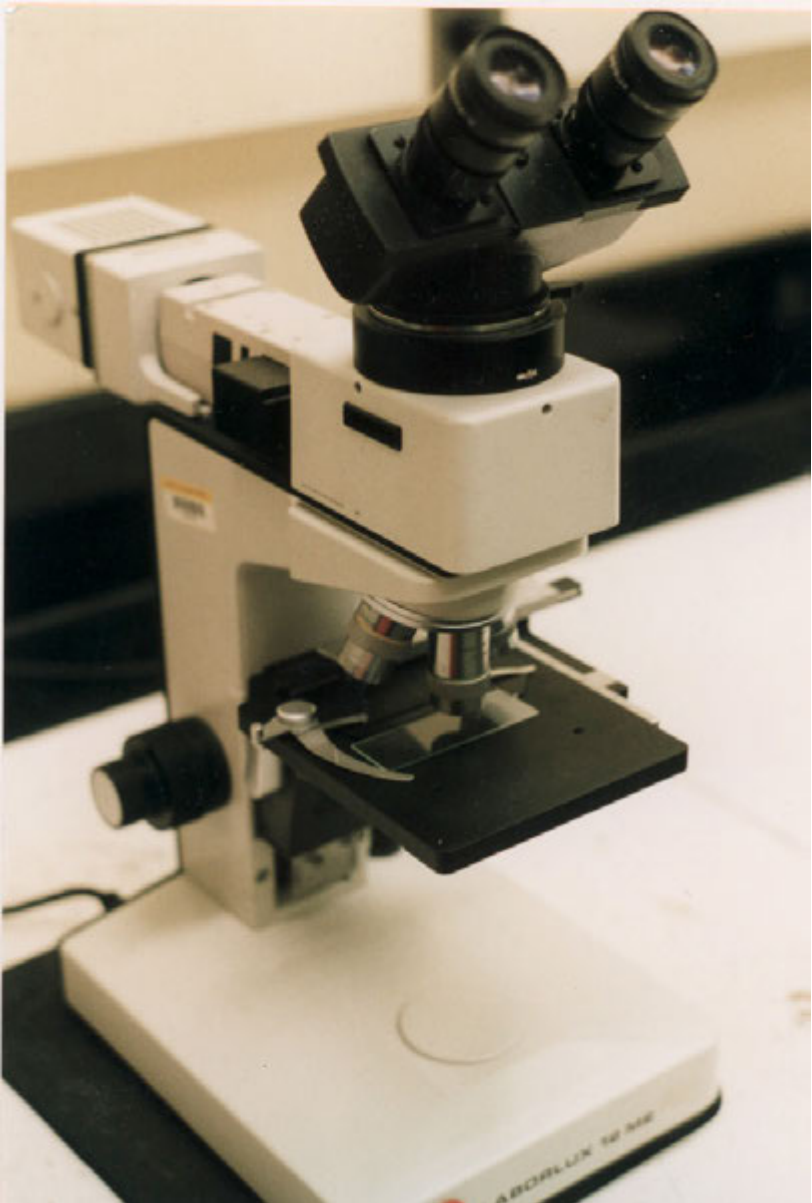
Figure 3.29 Compound reflected light microscope. Although the microscope has twin eyepieces, they both view the same image collected by the objective lens. Overall magnifications can be as much as 1000X, but the working distances and the depths of field are very small. Only relatively flat specimens may be examined.

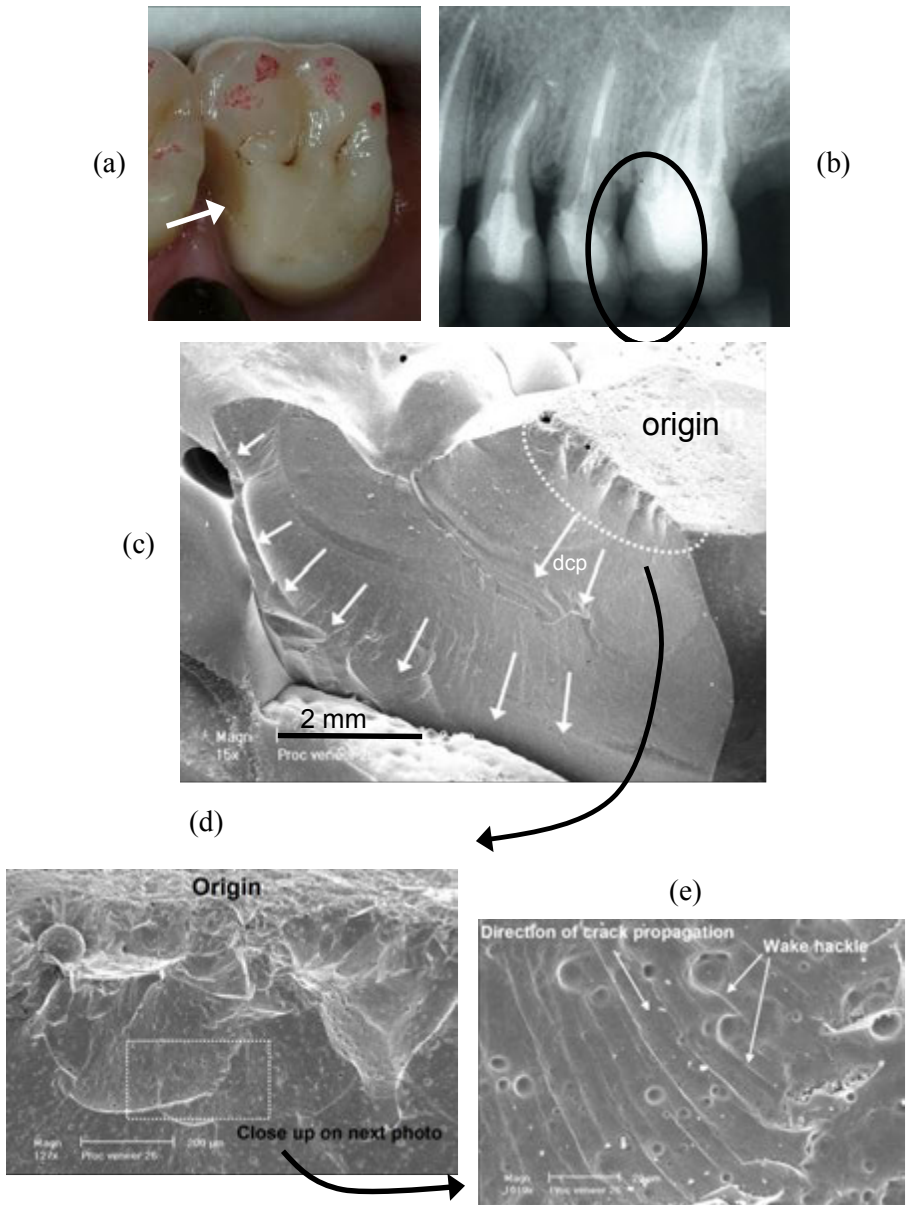
Figure 6.81 Failure of a first upper-left molar crown. (a) shows a view onto the occlusal surface (the crown top) and the chipped porcelain veneer on the side of the crown (arrow). The porcelain veneer was inadequately supported by the alumina core as shown in the x-ray image (b). (c) – (e) show progressive close-ups of the fracture surface on an epoxy resin replica. This is the same crown as shown in Figure 3.34 on replica techniques. (All courtesy S. Scherrer, Univ. Geneva)
